Manhole Inspection Summary

Manhole # S25EE1002MH

Location Address: **3800 FALLS RD** Cross Street: **DELLWOOD AVE**

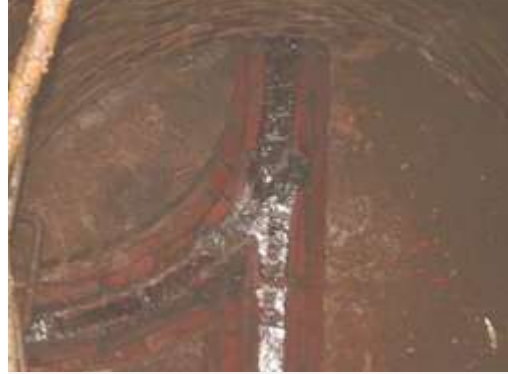
Top View

Bench ☒ Exists Material: **Brick** ☐ Parged ☒ **Debris** (not Condition related)

Steps Count: **5** Missing: **0** ☒ **Corroded**

Bench debris. Corroded steps.

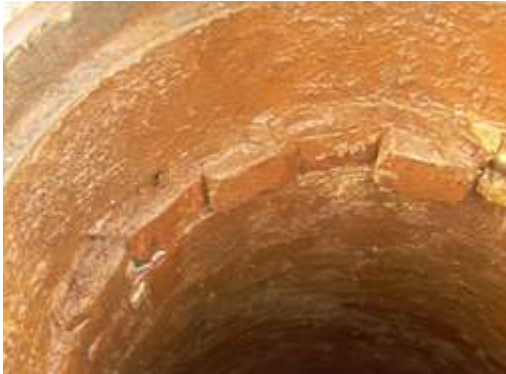
Defect

Frame Offset: **1** (in.) Condition: ☐ Sound ☐ Cracked ☒ **Leaks**

Condition: ☐ Sound ☐ Cracked ☐ Root Intrusion ☒ **Loose Brick** ☒ **Deteriorated**

Infiltration: ☐ None ☒ **Joint** ☐ Cracks ☒ **Mortar** ☐ Roots ☐ Wall

Frame leaks. Adjustment deterioration, loose brick, and infiltration.
